2017

Pavement Management System Update

Working to Improve  
our Streets and Alleys

City of Marysville  
526 C Street  
Marysville, CA 95901

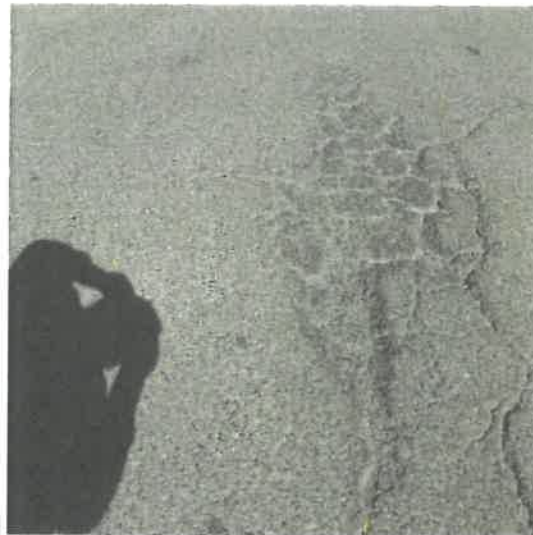
*Example of: Medium severity localized alligator cracking - C St between 2<sup>nd</sup> St and 3<sup>rd</sup> St (PCI 26)*

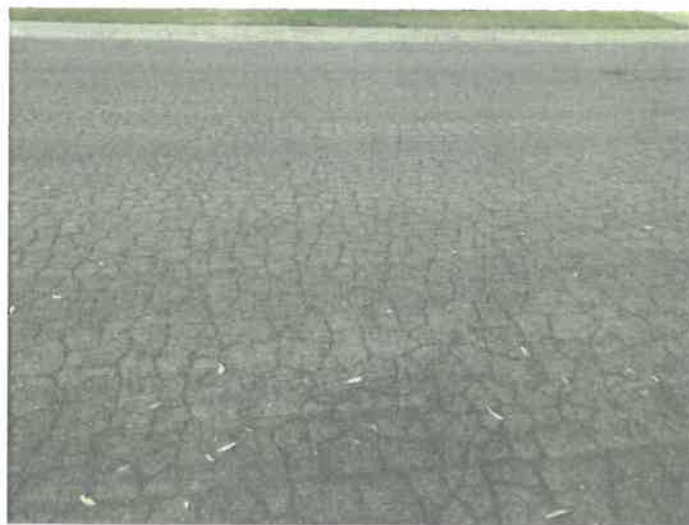
*Example of: Medium severity alligator cracking - Harris St between 19<sup>th</sup> St and Hall St (PCI 18)*

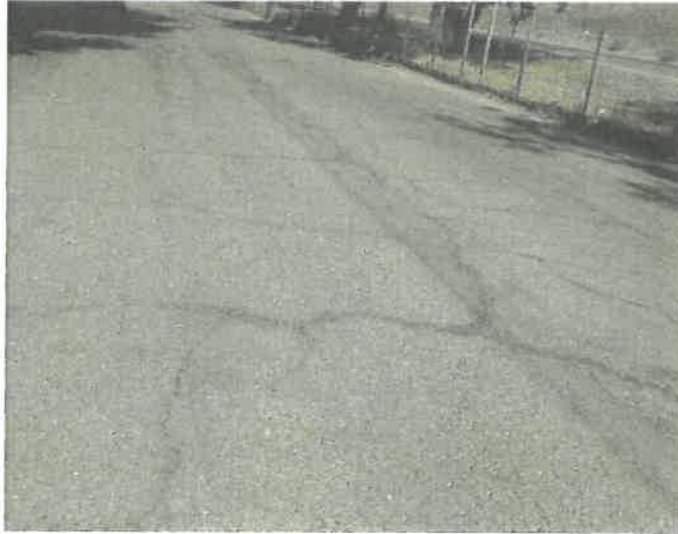
*Example of: Block Cracking on Glen St between Rideout St and 17<sup>th</sup> Street (PCI 20)*

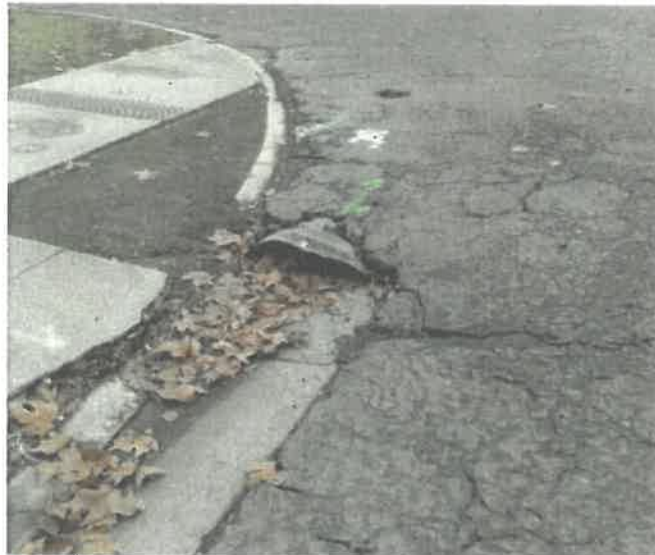
*Example of: Raising pavement at the culvert at the intersection of I St and 12<sup>th</sup> St (PCI 34)*

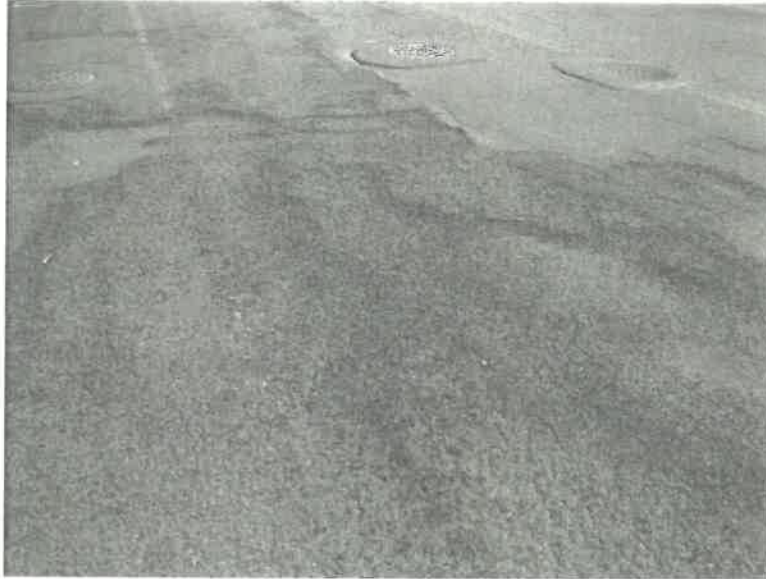
*Example of: Depressions and weathering on 1<sup>st</sup> ST between C St and D ST (PCI 26)*

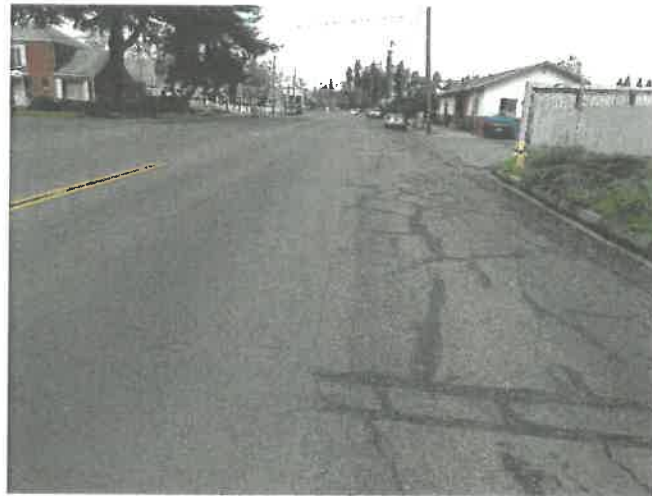
- 6) JT Cracking – Similar to Block Cracking and Longitudinal and Traverse Cracking, but it looks straight. Usually appears on an overlay surface.

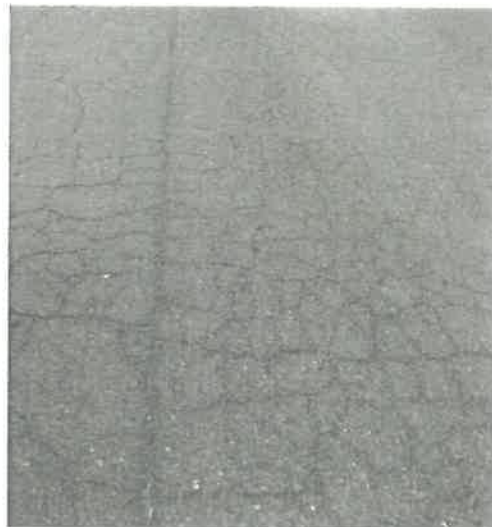
*Example of: L+T cracking with Alligator cracking - Huston St near Johnson St (HUS\_JOH\_22: PCI 11)*

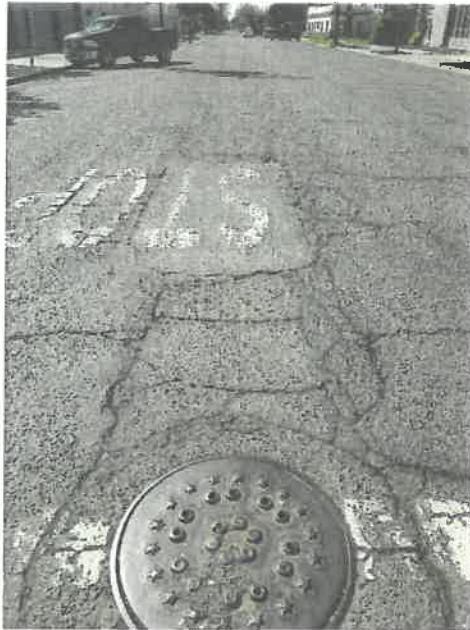
*Example of: Failing utility trench patch – 12<sup>th</sup> near E St (12TH\_E\_F: PCI 53)*

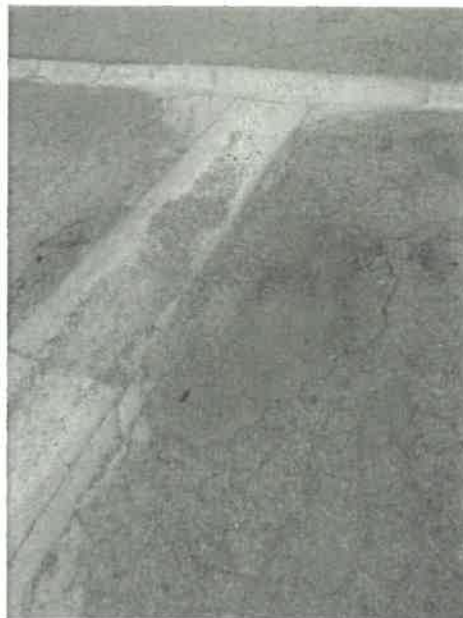
*Example of: Pothole on Freeman St at the intersection with 13<sup>th</sup> St (PCI 11)*

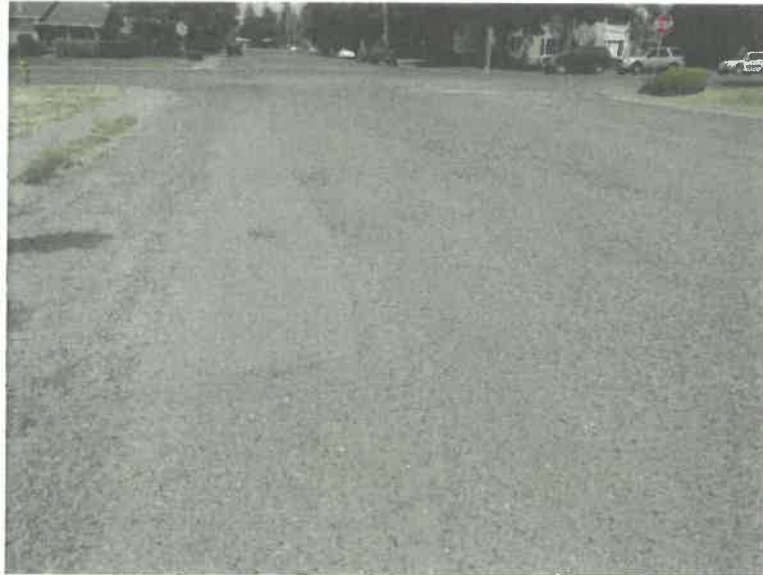
*Example of: High severity raveling - Sweezy St between 16<sup>th</sup> St and 17<sup>th</sup> St (PCI 8)*

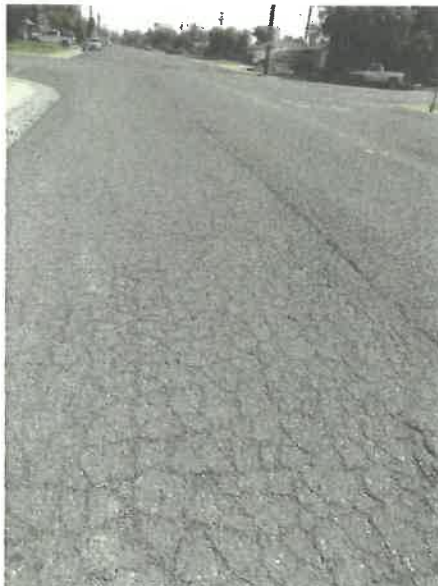
*Example of: Combination of weathering and high severity alligator cracking  
E19th St at the intersection with Sampson St, showing (PCI 8)*

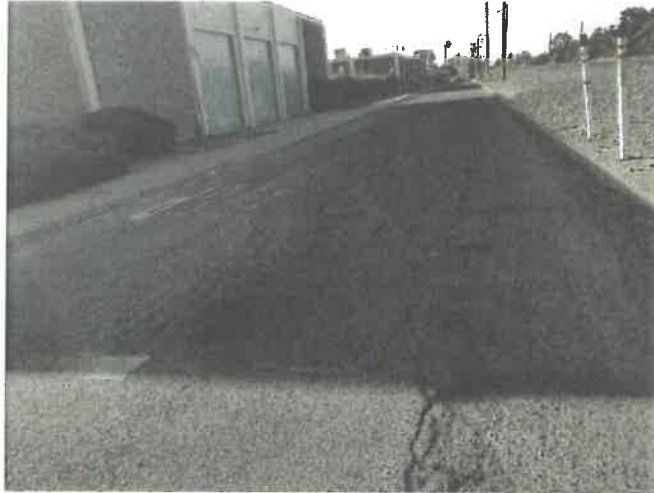
*Example of: Potholes, weathering, raveling, cracking, alligator cracking - A\_6\_4 intersection at 6<sup>th</sup> (PCI 7)*

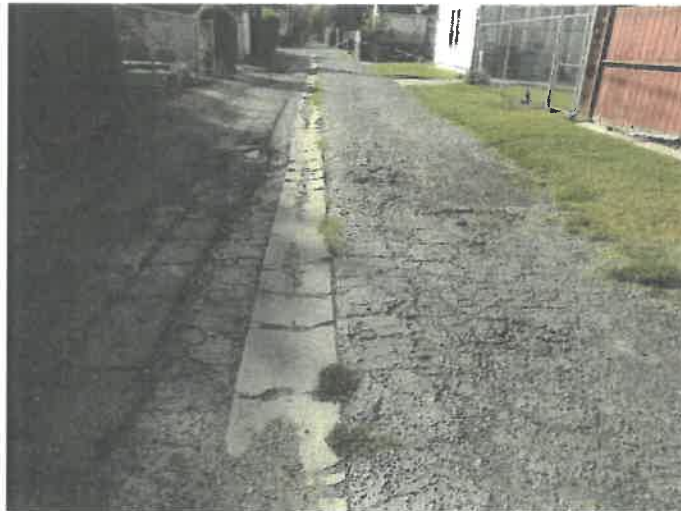
*Example of: High severity raveling, weathering, depression, and pothole, along with medium severity L+T cracking, alligator cracking, and utility cuts - Pine St between 6<sup>th</sup> St and 7<sup>th</sup> St showing (PCI 7)*
